# ANACOSTIA WATERSHED RIPARIAN FOREST BUFFER STUDY

# Anacostia Watershed Riparian Forest Buffer Study, Summer 1997

The following study was completed by the Maryland Department of Natural Resources – Forest Service for the United States Forest Service as part of a grant to study urban reforestation efforts along streams in the Anacostia watershed.

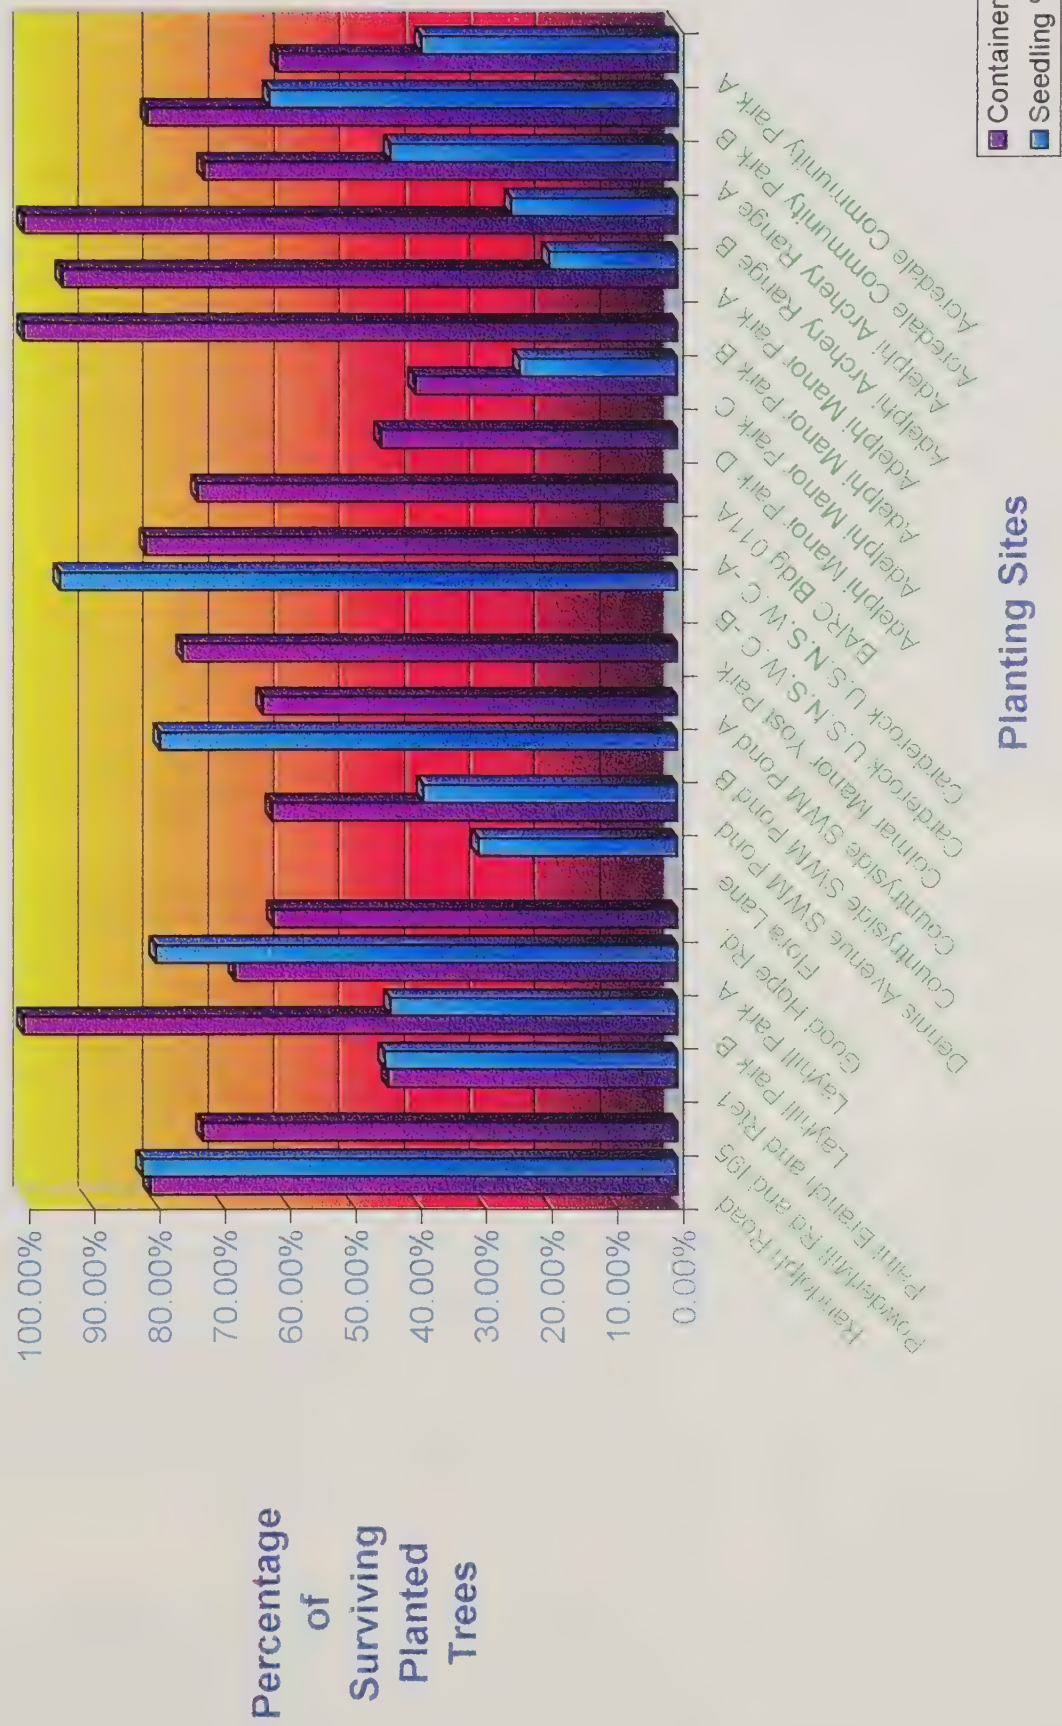
**Figure 3.**  
**Comparisson of Survival in Planted Seedlings**  
**and Container Trees.**

From this study, twenty-two riparian plantings were inventoried for a combined length of 11,619 feet (approximately 2.2 miles) of riparian forest with an average width of 85 feet. This equates to approximately 18.53 acres of new riparian forest in a highly urbanized watershed as a direct result of the Anacostia Watershed Project (Table 1). Twenty of the twenty-two planting sites studied were found to have greater than 200 trees per acre (Fig. 1). Including natural regeneration, three planting sites had densities greater than 1200 trees per acre (Fig. 1). The majority of planting sites had greater seedling tree density than container tree density (Fig. 2). Most planting sites possessed a much higher container tree survival rate than seedling tree survival (Fig. 3). Only three of the nineteen sites planted with container trees have survivals below 60%. In contrast, nine of the fourteen sites planted with seedlings have seedling tree survival rates below 45%. Although four of the seedling tree sites have a very high survival near or above 80%, two of these sites have never had container trees planted. Of the eleven sites with both container trees and seedlings planted, all but three plantings show container trees as having greater than a 20% higher survival rate than seedling trees. The remaining three planting sites have seedling survival rates only marginally higher than container tree survival rates.

The higher rate of container tree survival over seedling tree survival is a result of competition between seedlings and grass/weed species. Another possible explanation is that damage which may be evident upon a container tree as a mild stress may be enough to kill a less developed seedling. Container trees inherently have a higher

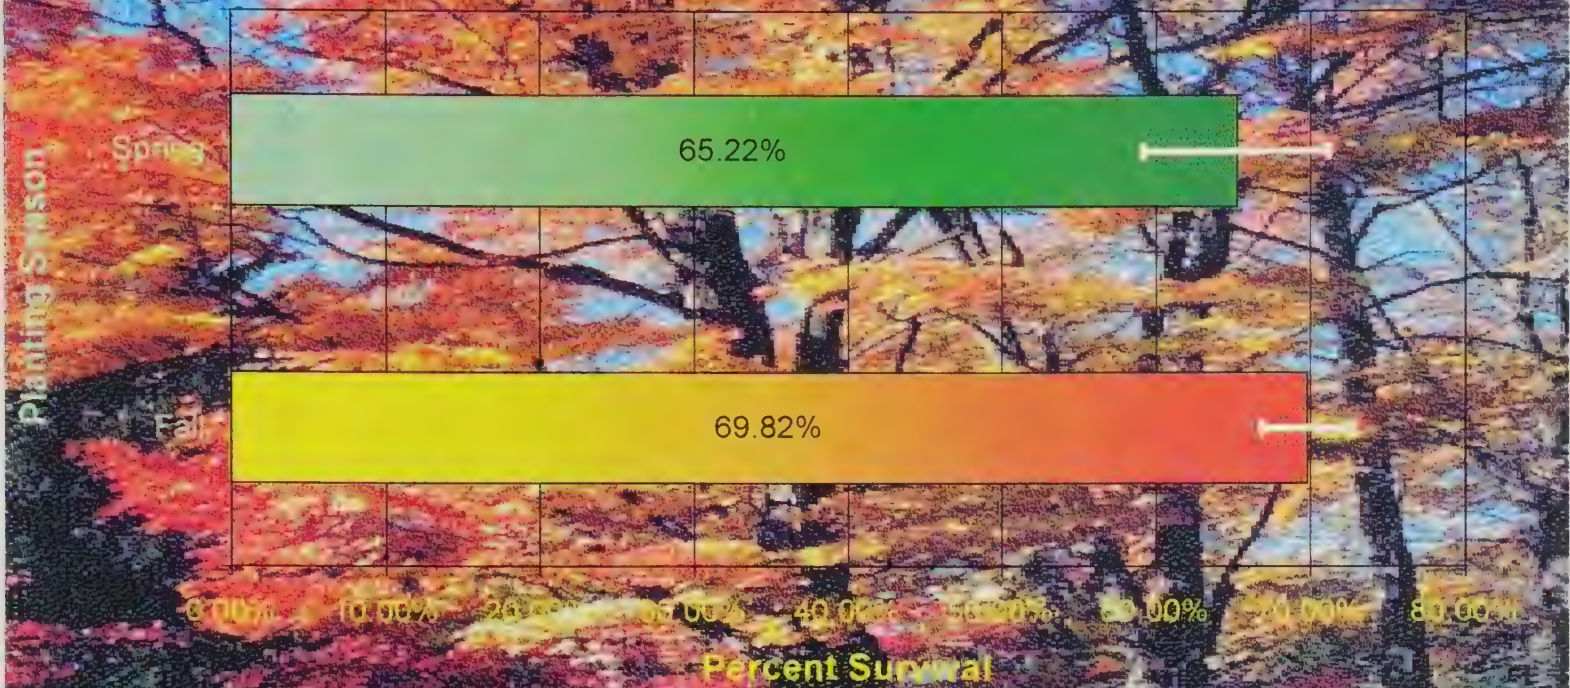
Figure 4A

There is only about a four and a half percent higher survivability for fall plantings than spring plantings (Fig. 4A). Taking into account the standard error of the means, there may be very little significant difference between the fall and spring planting season. Planting densities for container trees were much higher in the fall (Fig. 4B).

Container Tree Survival Compared by Planting Season  
With Standard Error of Means.

The results of comparing container tree survival by planting show that there is only a slightly higher survival rate for fall plantings over spring plantings. With a low standard error, this data is reliable and shows no significant difference in survival between fall and spring plantings. Fall plantings' container tree densities were much higher than spring planting densities as a result of more container trees being planted in the fall when seedling trees are not planted. Seedling trees have a higher planting priority in the spring requiring that less container trees are planted, due to limited resources.

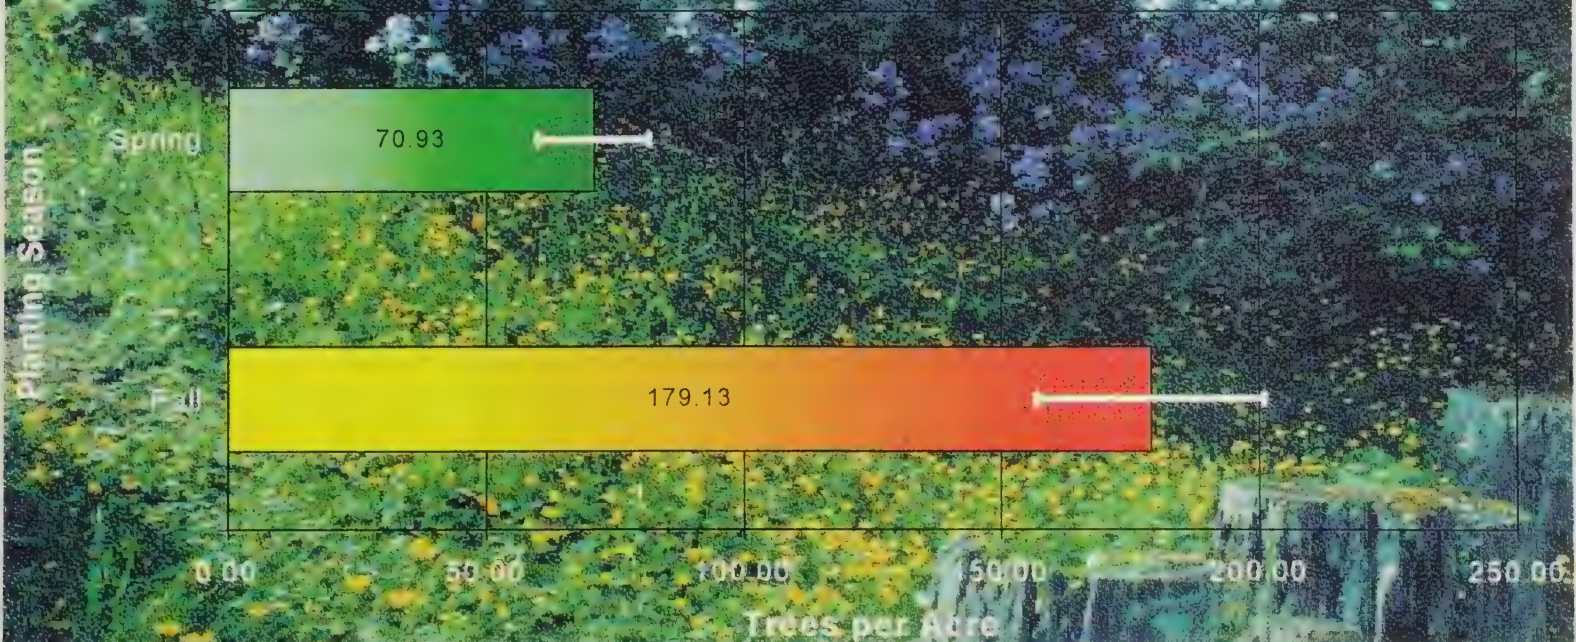
Figure 4B.

Container Trees per Acre Compared  
by Planting Season  
With Standard Error of Means.

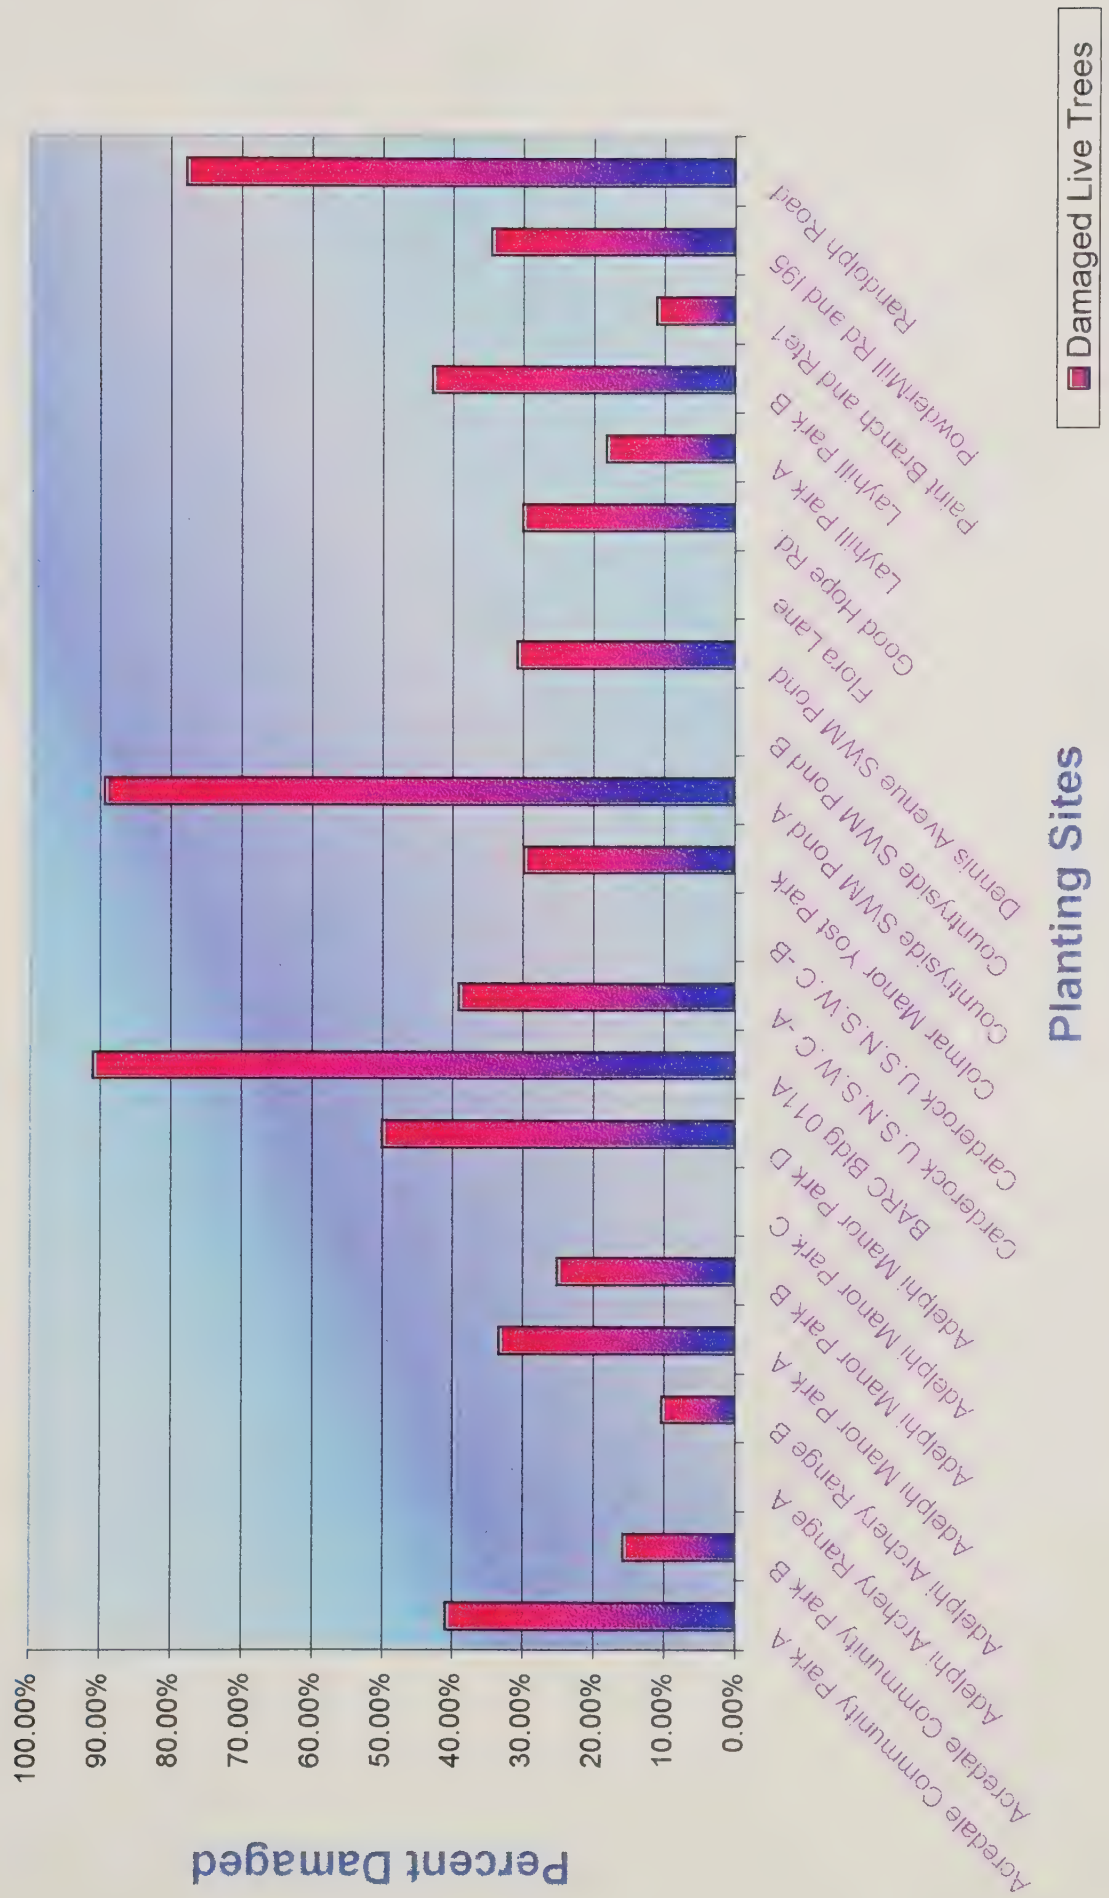
**Figure 5.**  
**Percentage of Living Container Trees with Damage**

Over 50% of the trees were damaged at four of the planting sites, with three of those sites having tree damage higher than 75% (Fig. 5). Five sites had no surveyed trees with any sign of damage evident. Deer herbivory was the leading cause of tree damage among the inventoried planting sites, affecting over a third of all surveyed trees (Fig 6). Rodents were the second most frequent cause of tree damage with 'other' causes of tree damage a close third. 'Other' was most often apparently drought damage, severe die back of the top of a tree for unknown reasons, and occasionally severe competition with vines. Lawn mower damage from mowing crews and trampling damage from construction vehicles also contributed considerably to tree damage, followed closely by damage caused from male deer rubbing their antlers against tree bark. Insect, beaver and disease damage contributed only slightly to tree damage.

Damage to surveyed trees was assessed to container, seedling, and volunteer trees, but because of their high monetary cost, container trees are the focus of this discussion. The majority of planting sites surveyed were not dominated by damaged container trees. Deer, rodents, and drought were the major causes of tree damage. Providing a watering regime during dry seasons, especially for the first year after planting, could improve survival rates considerably. Due to the cost and labor involved in watering planting sites, a study should be conducted to determine the effectiveness of a watering regime. The area studied is notorious for a large urban deer population so the impact deer had on buffer trees was less than what was expected. Herbaceous plants were heavily browsed at several sites with only low to moderate deer herbivory damage to container trees, suggesting that trees are browsed most when herbaceous plants are unavailable. Rodents were the second most frequent cause of surveyed container tree damage. Providing nesting boxes for owls may be an inexpensive way to control rodent populations. Nesting boxes would help reestablish urban owl populations and reduce damage to trees from rodents.

Only three locations had very high ratios of damaged container trees. The site suffering the most damage has already been mentioned but deserves a second look. The riparian forest buffer planting by BARC building 011A was one of two sites where a 100% tally of every tree in the planting site was conducted. Due to this, the data collected for this site is highly reliable. Of 150 planted container trees, 110 were surviving. The 40 trees unaccounted for are thought to have been mowed. Unfortunately, 100 (or over 90%) of these otherwise healthy trees have been damaged exclusively by irresponsible mowing and trimming. Due to the previously mentioned

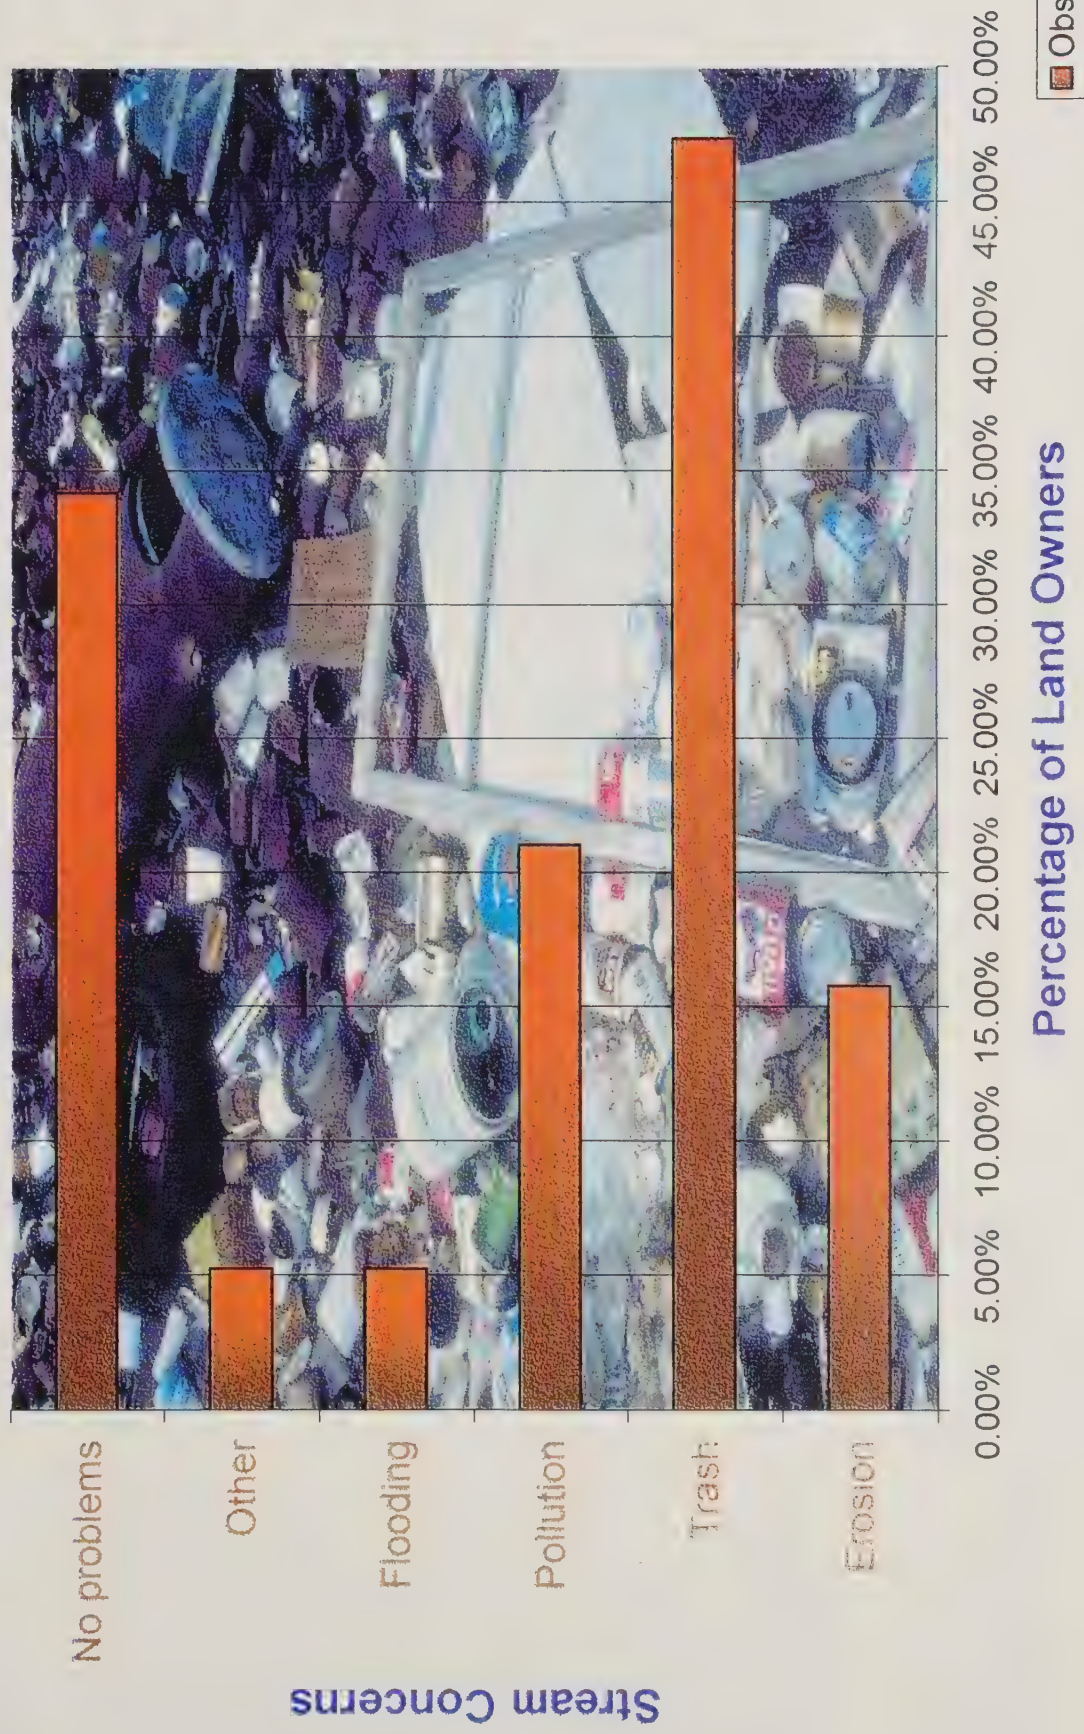
Figure 10.  
 Water Quality Problems Reported by Land Owners Residing in  
 the Anacostia Watershed.

Another part of the landowner survey questioned landowners about any water quality problems they had observed (fig. 10). Trash was the most frequently observed stream problem, reported by nearly half of the respondents. Landowners were also concerned with pollution and erosion. Flooding was a concern to about 5% of residents. About one third of the respondents have not noticed any stream problems. During the riparian buffer inventory, one of the streams in the surveyed communities was found to have a very large quantity of trash and badly needs a cleanup. Several stream cleanup projects have been carried out at that location in recent years, but the trash is a

reoccurring problem. Street and sewer runoff is the most likely source of trash in these streams, and will continue to be problematic as long as careless trash disposal occurs.
